Coal Mine Fatal Accident 2005-10

Operator:	Sunrise Coal Company, LLC
Mine:	NEWCO #1 Mine
Accident Date:	July 12, 2005
Classification:	Fall of Roof
Location:	Dist. 11, Jefferson Co., Alabama
Mine Type:	Underground
Employment:	43
Production:	1,300 tons/day

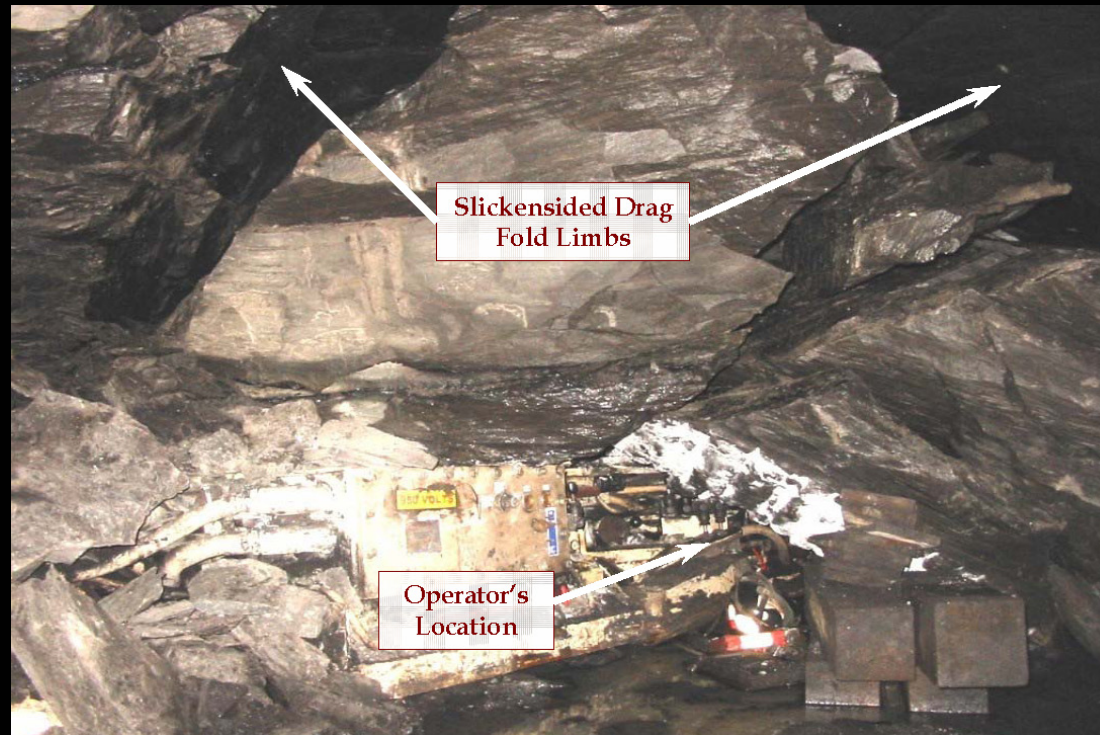
At ~10:45 a.m. on Tuesday, July 12, 2005, a 28-year old mobile bridge conveyor operator was fatally injured in a roof fall. The victim, positioned in an intersection under permanently supported roof, was operating the No. 3 mobile bridge conveyor when a drag fold (horseback) fell in the intersection and inby toward the face. The victim had 13 months total mining experience, all at the NEWCO #1 Mine, and 12 months experience as a mobile bridge conveyor operator.

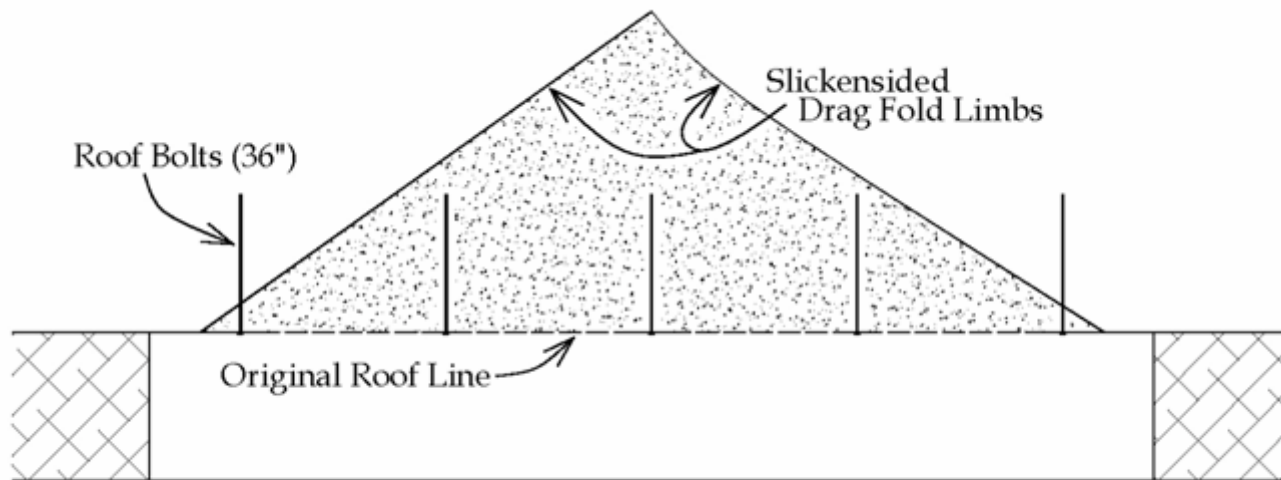
Causal Factor: The operator failed to recognize adverse roof conditions that would have prompted installation of longer roof bolts on reduced centers and reduction in entry width in compliance with the approved roof control plan. The presence of a slickensided drag fold (horseback) running nearly parallel to the No. 4 entry was not identified by mine personnel. The maximum thickness of the wedge block beneath the drag fold exceeded roof bolt anchorage by three to five feet. Roof competency was further degraded by localized areas of water inflow. The primary roof support system was not adequate to prevent the roof fall.

The accident occurred because the operator did not recognize the presence of a drag fold (horseback) and failed to comply with provisions of the approved roof control plan regarding specific actions to be taken when adverse roof conditions, including horsebacks, were encountered. The victim was located in a permanently supported intersection when the roof failed above the anchorage horizon of the roof bolts. The primary support system was not adequate to prevent the roof fall.

Corrective Actions: The operator is in the process of abandoning the NEWCO #1 Mine. However, the operator has acquired another mine and has requested that Technical Support conduct hazard mapping to identify potential roof problems. This will assist the operator by providing knowledge and awareness of potential hazards that can be expected at the mine. Hazard mapping will also provide miners and management with the knowledge needed to identify potential roof problems on working sections and in outby areas so that suitable support can be used to prevent roof failures. Hazard mapping will be recommended and should be conducted if the mine associated with I.D. No. 01-03102 is re-opened for operations in the future.
